Coal Combustion Residue Impoundment Round 9 - Dam Assessment Report

Miller Steam Plant

Coal Combustion Residue Impoundment Dike Alabama Power Company West Jefferson, Alabama

Dewberry & Davis, LLC Fairfax, Virginia

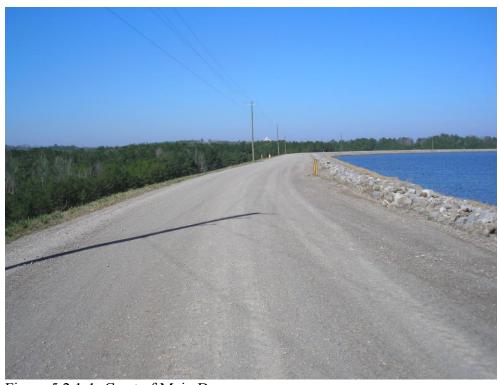
Figure 5.2.1-1: Crest of Main Dam

The crest of the CCR impoundment main dam had no signs of depressions, tension cracks, or other indications of settlement or shear failure. Previous inspection reports reviewed by Dewberry did not indicate issues concerning the crest of the main dam. Figure 5.2.1-1 shows the condition of the main dam crest.

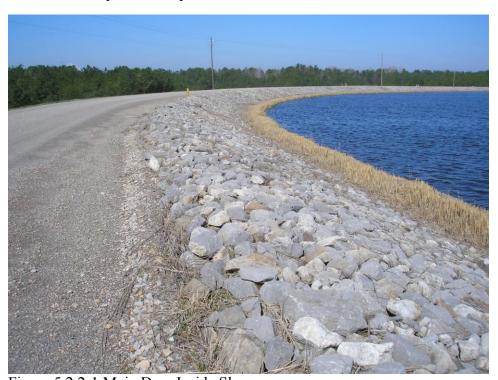
Figure 5.2.2-1 Main Dam Inside Slope

The inside slope of the CCR impoundment main dam is armored with riprap to protect the slope from erosion caused by wind generated waves. Grass was observed growing in the rip-rap along the water line. There were no observed scarps, sloughs, bulging, cracks, depressions, or other indications of slope instability or signs of erosion. Figure 5.2.2-1 shows a section of the upstream slope of the main dam.

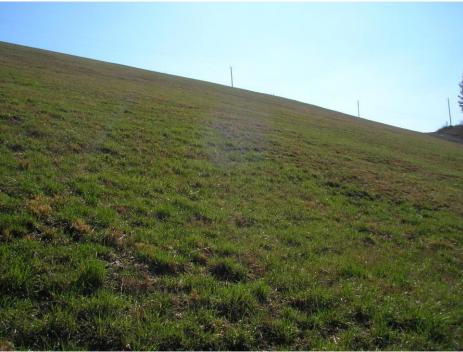
Figure 5.2.3-1 Main Dam Outside Slope

The downstream or outside slope of the CCR impoundment main dam is protected by several species of grass and weeds. There were no observed scarps, sloughs, bulging, cracks, depressions, or other indications of slope instability or signs of erosion. Figure 5.2.3-1 shows a section of the downstream slope of the main dam.

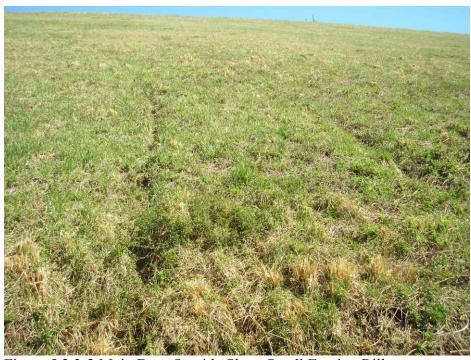
Widely scattered, small erosion rills were observed in the downstream slope. Figures 5.2.3-2 shows an erosion rill.

Figure 5.2.3-2 Main Dam Outside Slope Small Erosion Rill

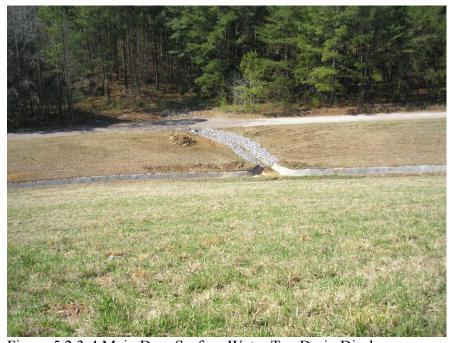
Figure 5.2.3-4 Main Dam Surface Water Toe Drain Discharge

Stormwater runoff from the main dam outside slope is captured by a concrete lined ditch located along the abutments and toe of the slope. The drain discharges to a riprap lined ditch that empties into a creek in the woods beyond the toe of the dam embankment. Figures 5.2.3-3 and 5.2.3-4 show the concrete-lined ditch and the discharge drain, respectively.

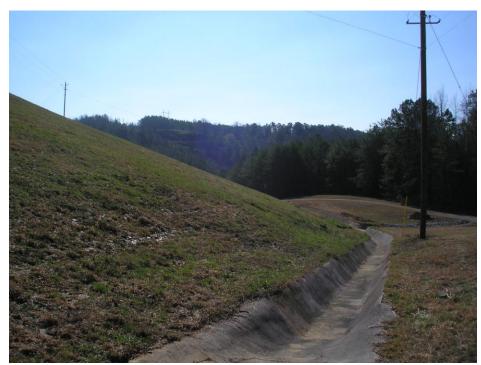
A few isolated wet areas were observed near the outside toe of the dam (see Figure 5.2.3-5). No evidence of flowing water was observed. It could not be determined if the source of water was minor seepage through the embankment or residual precipitation from recent storms.

Figure 5.2.3-5 Wet Area Outside Slope of Main Dam Toe

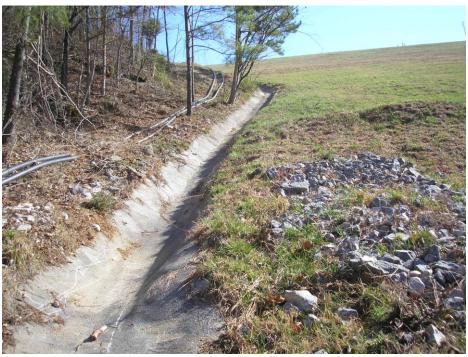
Figure 5.2.4-1 Main Dam North Abutment

Erosion or uncontrolled seepage was not observed along the abutments. The abutments appeared to be in good condition. Figures 5.2.4-1 and 5.2.4-2 show the north and south abutments, respectively.

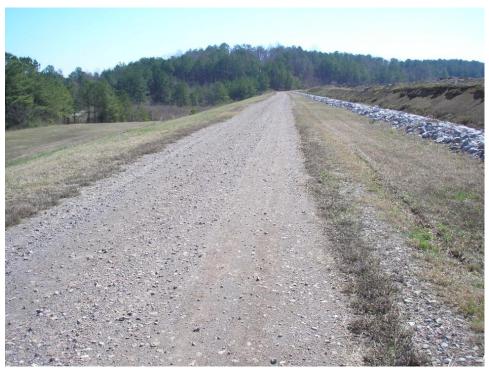
Figure 5.3.1-1 Crest of Saddle Dike

The crest of the CCR impoundment saddle dike had no signs of depressions, tension cracks, or other signs of settlement or shear failure. Previous inspection reports reviewed by Dewberry did not indicate issues concerning the crest of the main dam. Figure 5.3.1-1 shows the condition of the saddle dike crest.

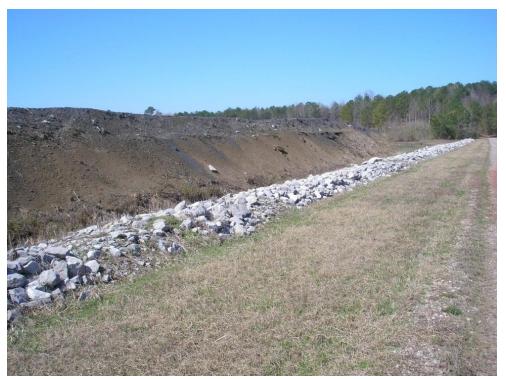
The upstream slope of the CCR impoundment saddle dike is armored with rip-rap, originally to protect the slope from erosion caused by wind generated waves. The impoundment in the area of the saddle dike has been filled with ash such that the embankment inside slope is no longer exposed to wave action. There were no observed scarps, sloughs, bulging, cracks, depressions, or other indications of slope instability or signs of erosion. Figure 5.3.2-1 shows a section of the upstream slope of the saddle dike.

Figure 5.3.2-1 Saddle Dike Inside Slope on Right and Impoundment Ash Fill on Left.

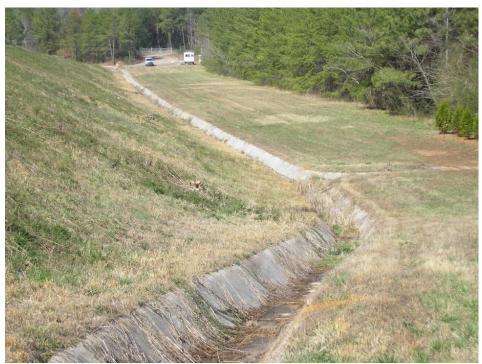
Figure 5.3.3-1 Saddle Dike Outside Slope

The downstream or outside slope of the CCR impoundment saddle dike is protected by several species of grass and weeds. There were no observed scarps, sloughs, bulging, cracks, depressions, or other indications of slope instability or signs of erosion. Figure 5.3.3-1 shows a section of the outside slope of the saddle dike.

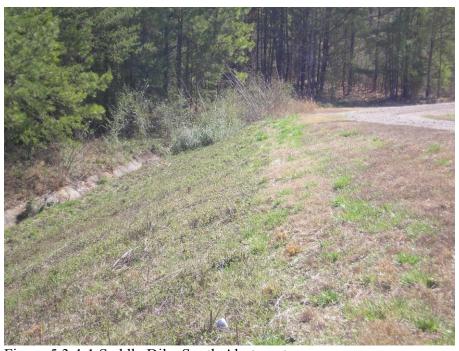
Figure 5.3.4-1 Saddle Dike South Abutment

Erosion or uncontrolled seepage was not observed along the abutments. The abutments appeared to be in good condition. Figure 5.3.4-1 shows the south abutment.

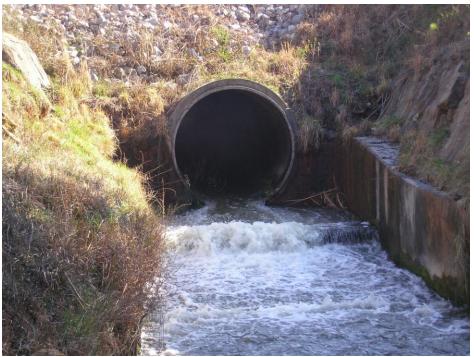
The outlet conduit appeared to be in good condition and operating normally with no sign of clogging. Water flowing from the outlet was clear. Figure 5.4.2-1 shows the water discharging from the outlet conduit.

Figure 5.4.2-1 Water Flowing from Impoundment Overflow Discharge Conduit

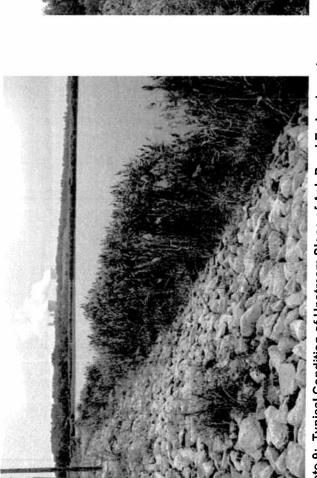
The inspection team then observed the discharge structure at 96+18 of the main dam. There was flow through the structure at the time of the inspection (Photos 7 and 8). No problems were noted at either the inlet or the outlet. Following the observation of the discharge structure, the crest of the dam was inspected. The wide crest road and the upstream riprap were observed to be in excellent condition. Vegetation was observed in portions of the riprap (Photo 9). It is recommended that this vegetation be removed by spraying.

Photo 9: Typical Condition of Upstream Slope of Ash Pond Embankment

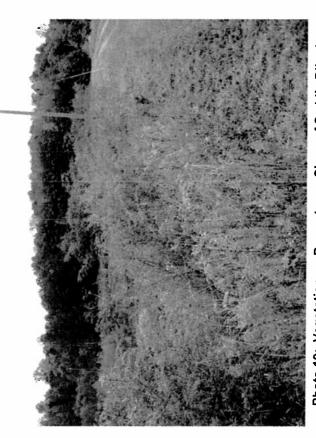
The saddle dam adjacent to Porter Road (northeast of the main dam) was also inspected. Operations have resulted in most of the pond in the area being filled with ash. The saddle dam appears to be performing adequately, but dense vegetation and trees were observed on the downstream face of the dike (Photos 10 and 11).

Photo 10: Vegetation on Downstream Slope of Saddle Dike 1

The filling of the pond in the area of the saddle dam has diminished its importance as a water retaining structure. However, it is recommended that this structure continue to be inspected and that vegetation be removed from the slope to allow adequate inspection. No other problems or unusual conditions were noted. Drainage in the area just downstream of the saddle dam, which has been a problem in the past due to beaver activity, appeared to be satisfactory at the time of the inspection.

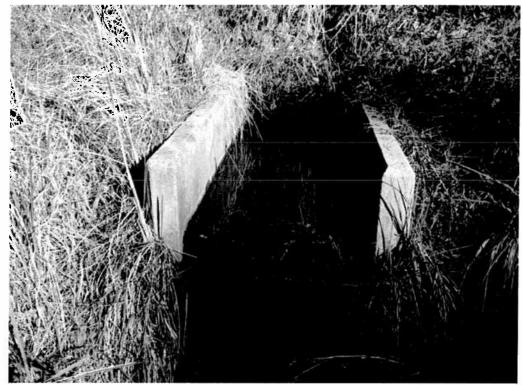
Photo 7: Condition of Weir 1

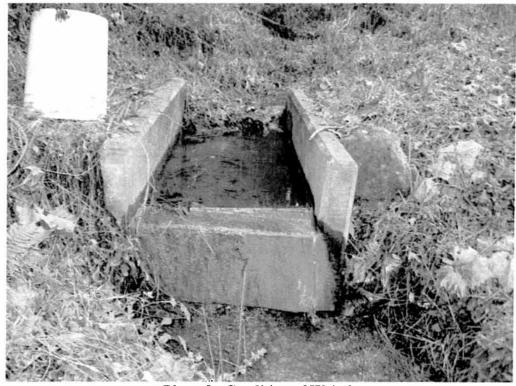
Photo 8: Condition of Weir 2

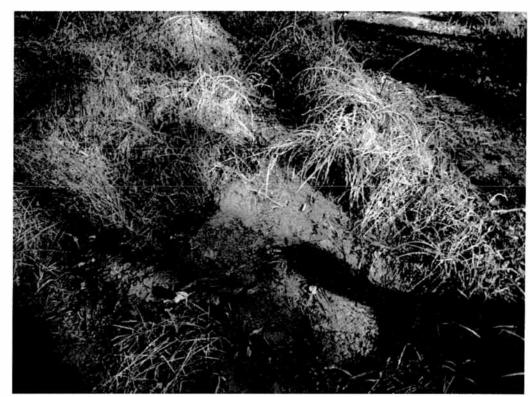
Photo 9: Seepage Along Access Roadway

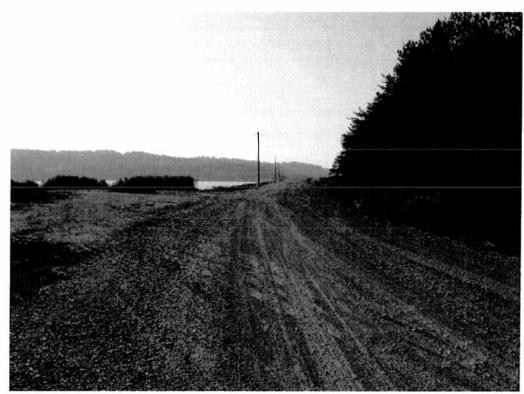
Photo 3: Condition of Main Ash Pond Dam Crest, Typical

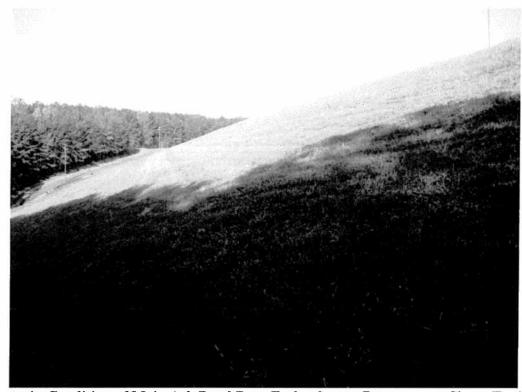
Photo 4: Condition of Main Ash Pond Dam Embankment Downstream Slope, Typical

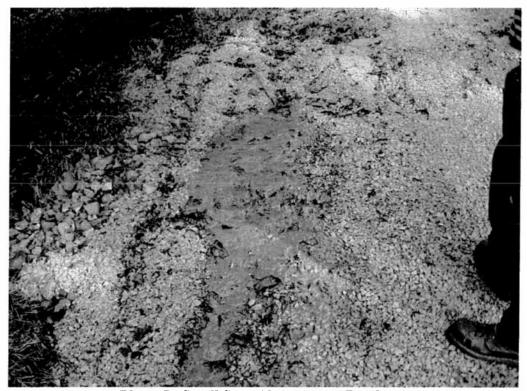
Photo 5: Small Seep Along Access Roadway

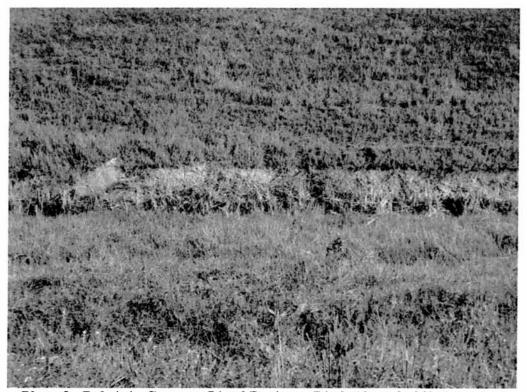
Photo 8: Debris in Concrete Lined Drainage Ditch Along Saddle Dam Toe

No.	Description	Location
1	It is recommended that the current level of embankment maintenance at the main ash pond dam (on both the upstream and downstream slopes) be continued.	Main Ash Pond Dike (see Photo #4)
2	It is recommended that the plant staff clear the debris from the drainage ditches along the main ash pond dam embankment toe so that they are allowed to flow freely, and future maintenance efforts should include provisions to keep them clear.	Main Ash Pond Dike
3	It is recommended that the current level of embankment maintenance be maintained at the saddle dike.	Saddle Dike (see Photo #7)
4	It is recommended that the plant clear the debris from the drainage ditch along the saddle dike embankment toe so that it flows freely.	Saddle Dike (see Photo #8)
